ABBREVIATED PRELIMINARY ASSESSMENT

BLACK JACK MINE

Umatilla National Forest
Grant County, Oregon

March 2003

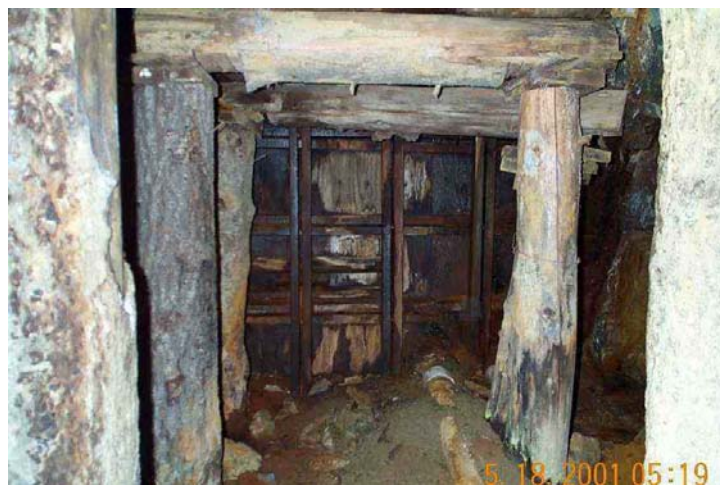
Bulkhead – Upper Adit

The Site consists of two adits of which the upper adit is currently sealed off with a bulkhead. Water is drained from the adit via PVC piping, which goes underneath Clear Creek and is intentionally discharged to a man-made wetland on the opposite side of Clear Creek from the Site. The lower adit discharges water directly into Clear Creek. The Site consists of a large waste pile. The waste pile is situated on top of steep side slopes and in the flood zone of Clear Creek. There are no structures, other than the adit, in the area. Accessing the site requires crossing Clear Creek on foot, as there are no bridges or roads on the Site. Approximately two acres are disturbed on the Site.

Based on visual observation, the material is similar to the Bluebird mine. Acid Mine Drainage (AMD) from the upper adit drains into a wetland area that is now approximately 20 years of age. The lower adit discharges AMD directly into Clear Creek. There are apparent signs of the pipeline for the upper adit malfunctioning.

Based upon visual observations, it is recommended that an SI be performed. As part of this inspection process, it is recommended that the wetlands be tested and assessments made as to its life expectancy.

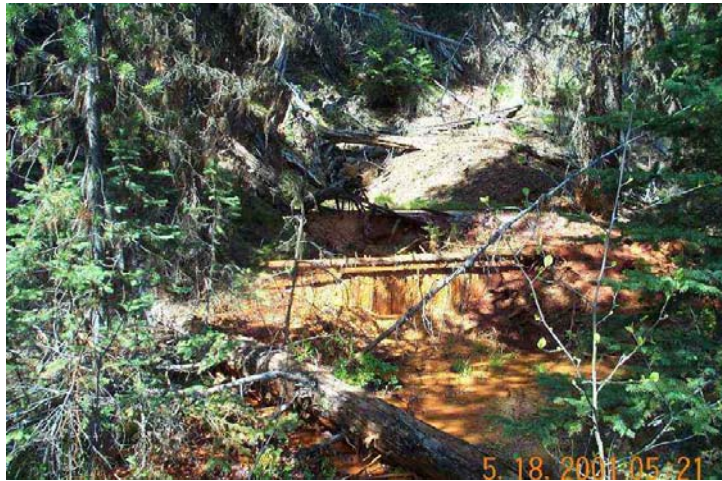
Describe the release (or potential release) and its probable nature: Clear Creek runs about 75 feet from the toe of the waste pile. AMD discharges directly into Clear Creek

*Yellowboy – Clear Creek
Riparian Area*
